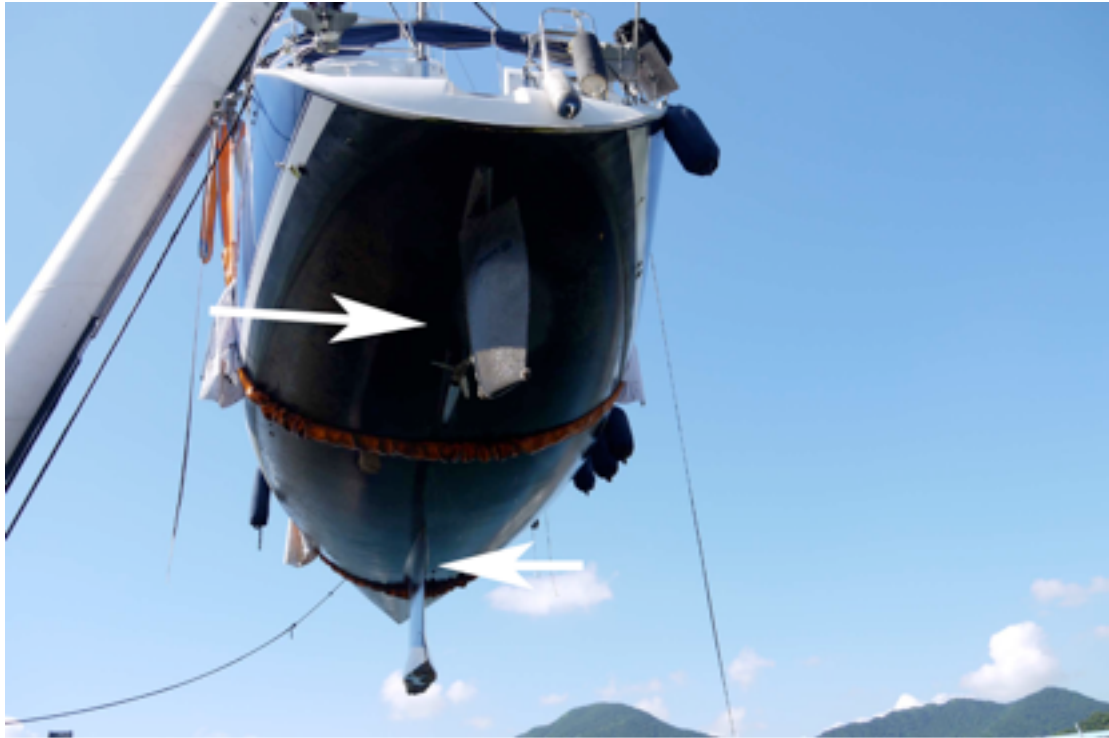
1. LOCATION OF TRANSDUCERS AND CONDITION OF HULL WHEN LIFTED AFTER 20 MONTHS.

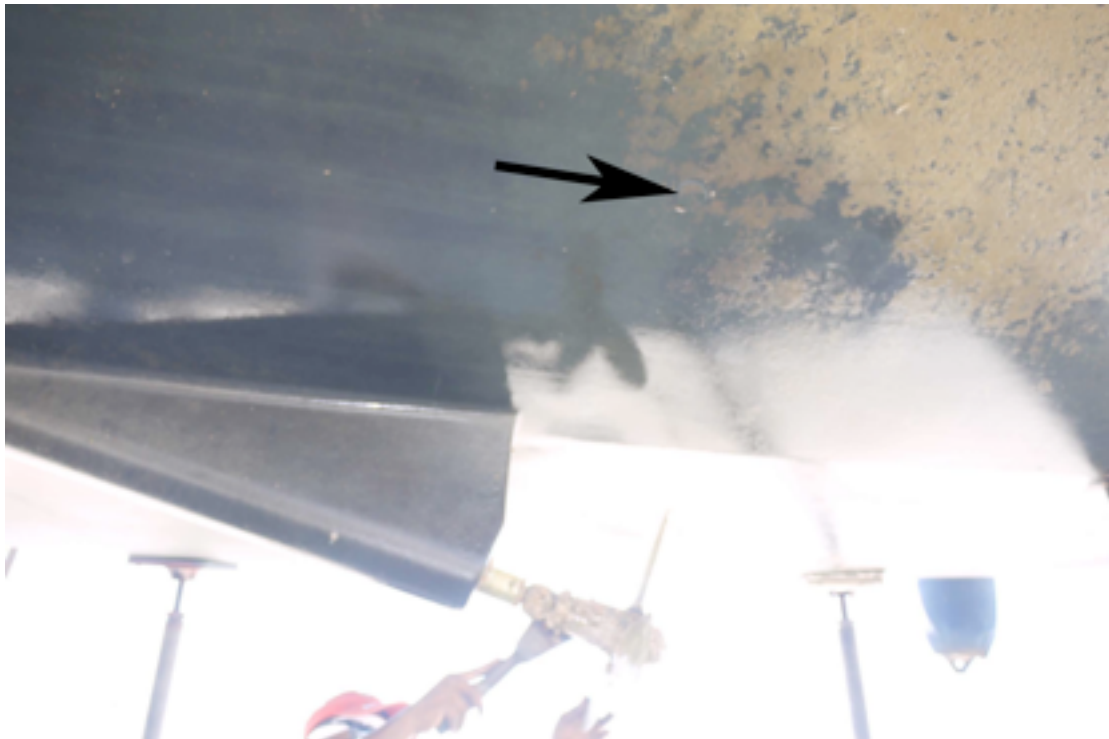
2. LOCATION OF AFT TRANSDUCER. NOTE LACK OF FOULING.

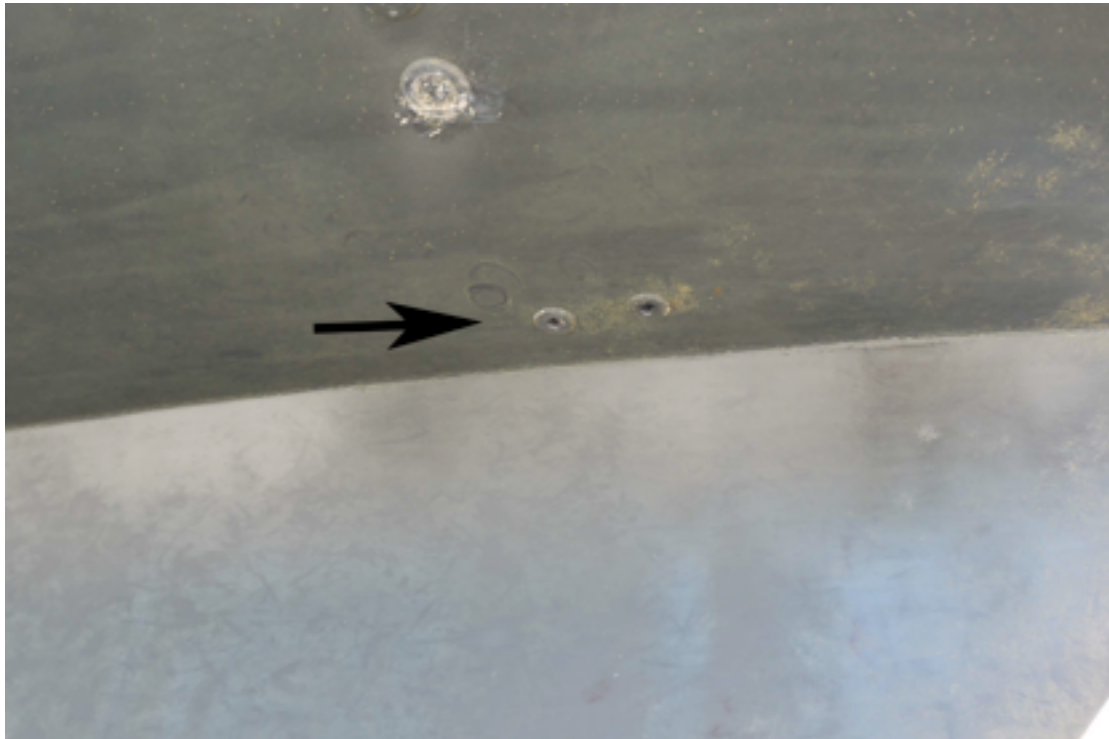
3. LOCATION OF FORWARD TRANSDUCER BOW IS TO THE RIGHT. AGAIN, THERE IS NONE OF THE USUAL FOULING.

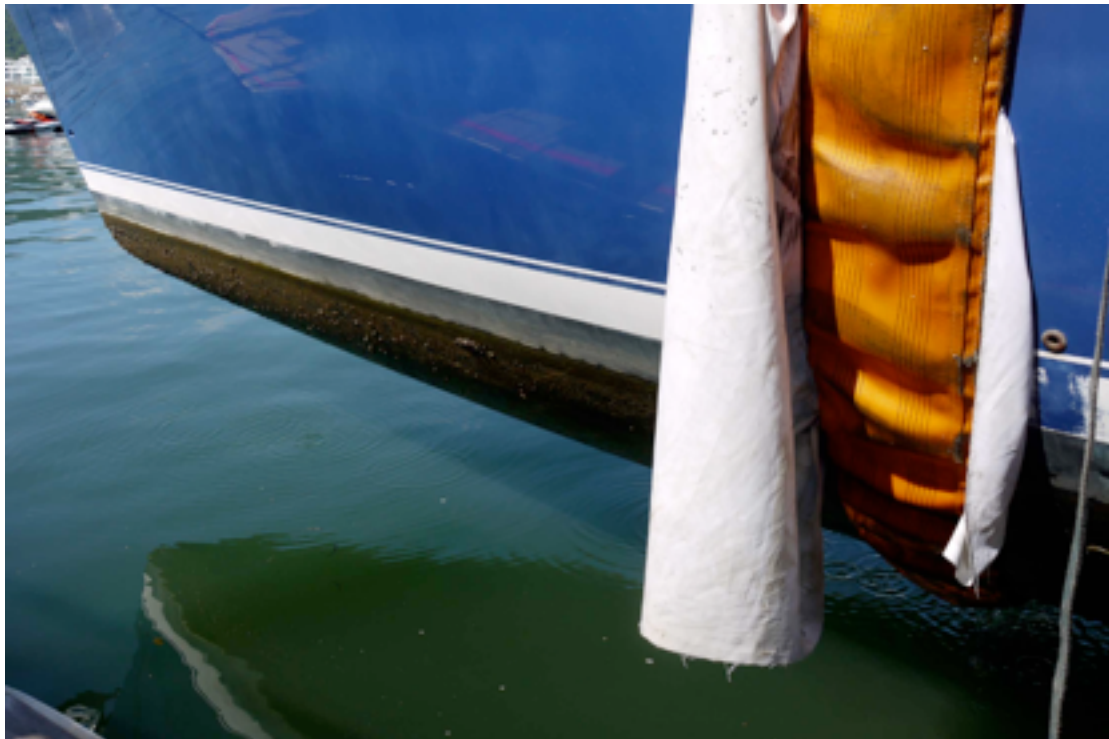
4. BOW AND MINIMAL BARNACLE BUILDUP.

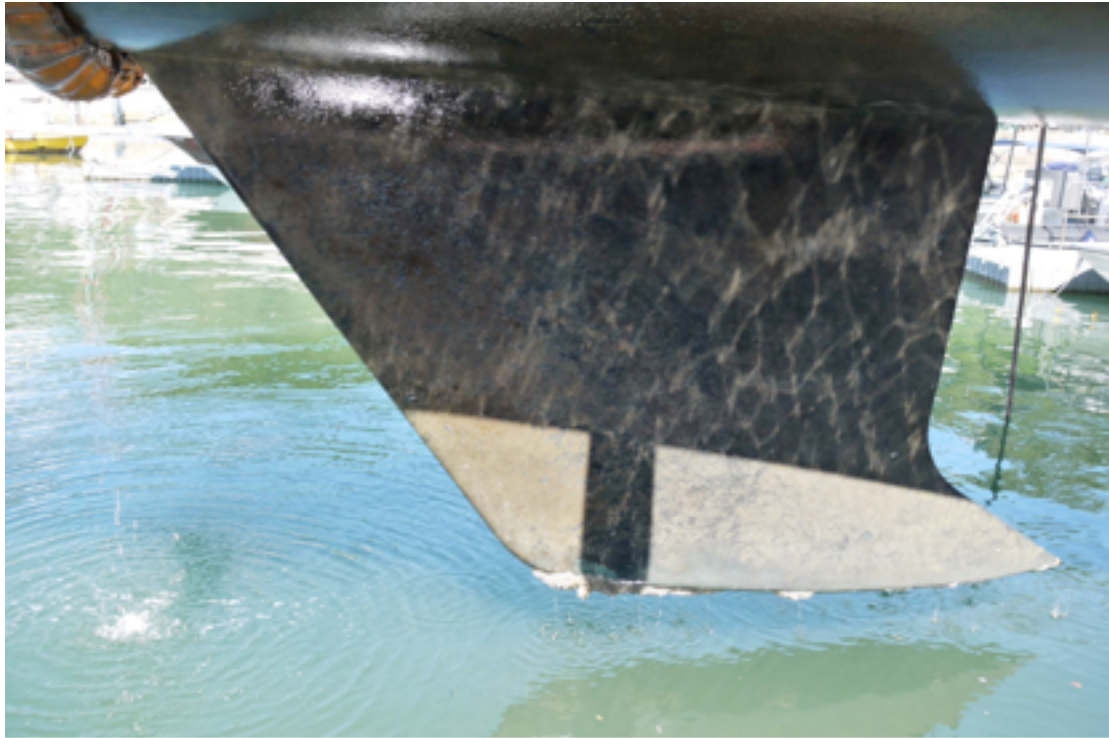
5. KEEL. FOULING POSSIBLY DUE TO 'BUMPING' THE BOTTOM DURING LOW TIDES.

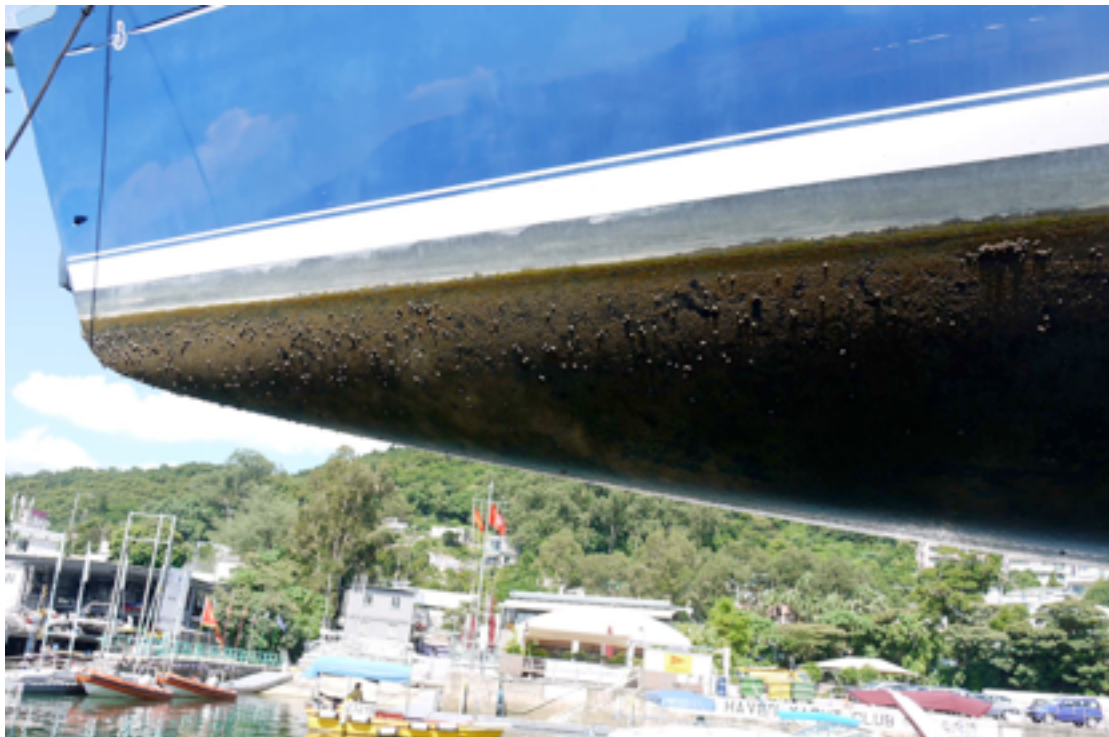
6. ANOTHER VIEW OF THE FORWARD HULL AND MINIMAL BARNACLE BUILDUP.

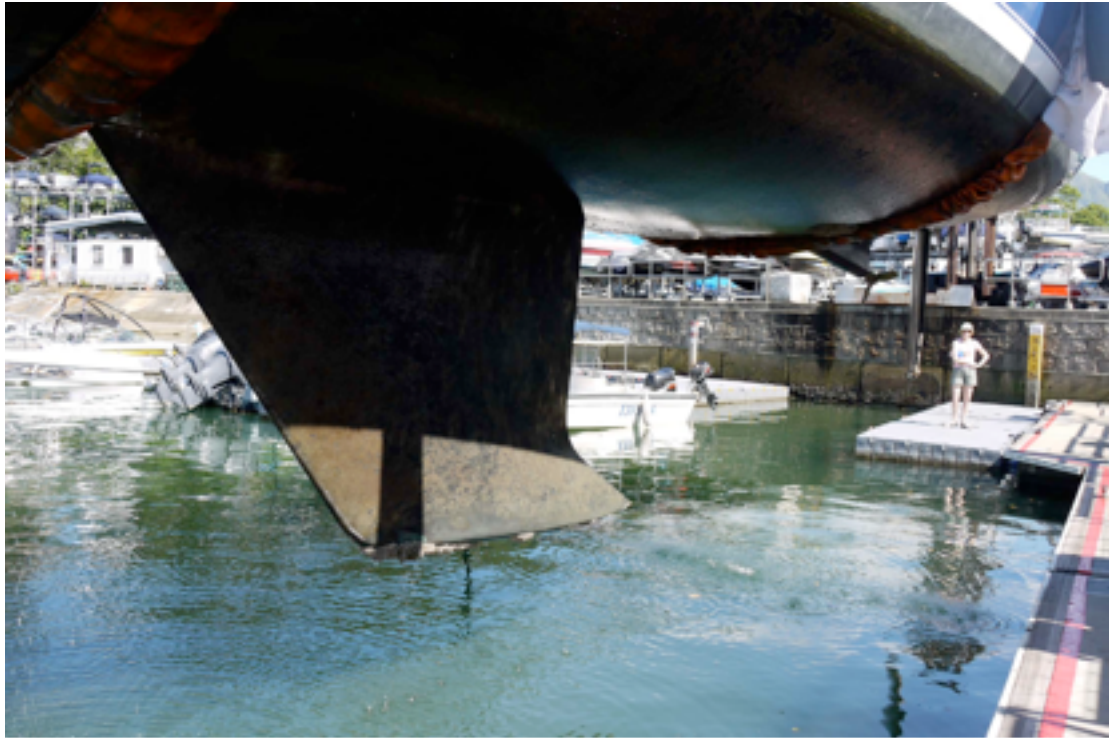
7. KEEL SOON AFTER LIFTING.

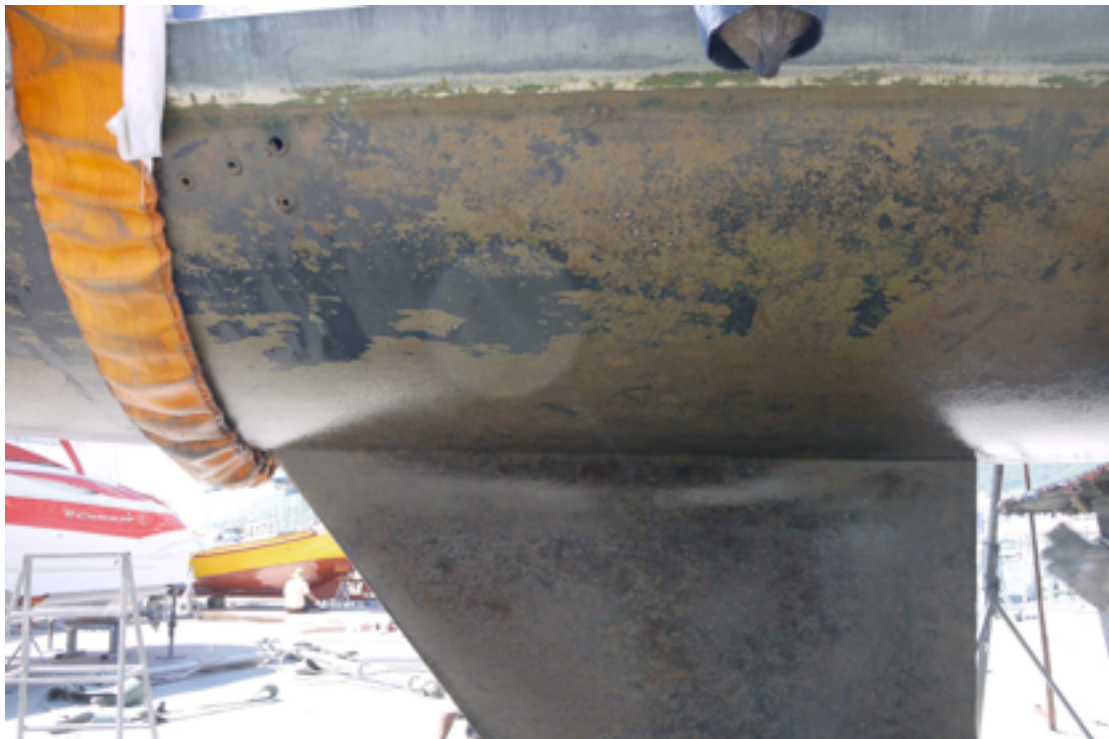
8. PORT SIDE OF KEEL PRIOR TO CLEANING AFTER 20 MONTHS.
